DISC LASER AMPLIFIER

ILC Report
R-ILC-73-8

10 April 1973

Naval Research Laboratory

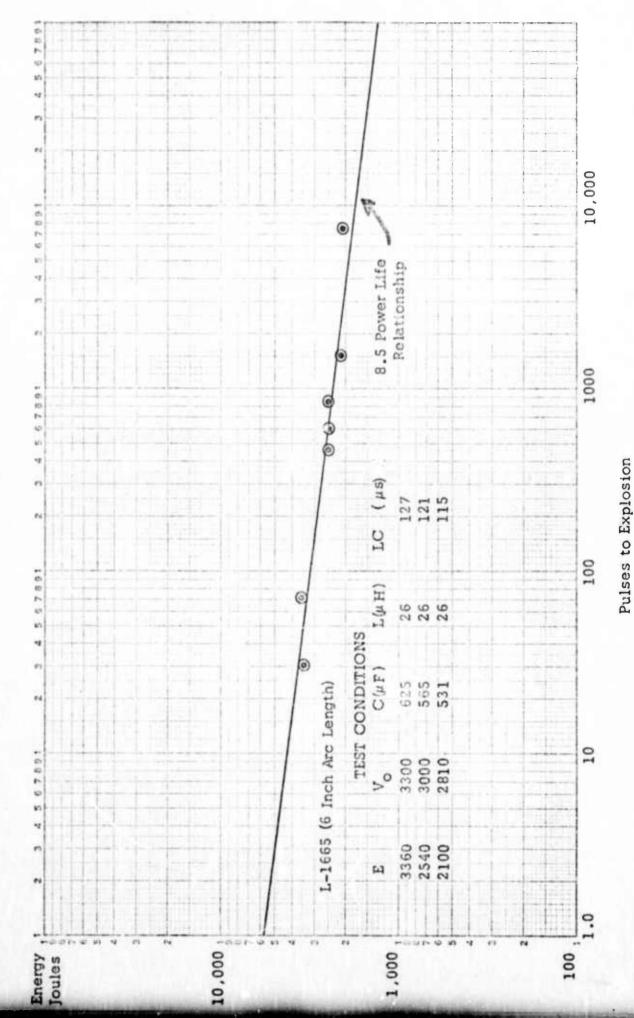
FIGURE 2. HIGH ENERGY LIFE TESTS

The test results of the program are presented in Figures 2 through 5. In all cases the termination of a test sequence occurred when the lamp envelope fractured. In all cases except one, lamp fracture was violent and resulted in virtually total destruction of the lamp envelope.

It is also interesting to note that for the 6 inch lamp data (Figure 2) the best fit lamp life slope and the previously established lamp life slope are essentially the same.

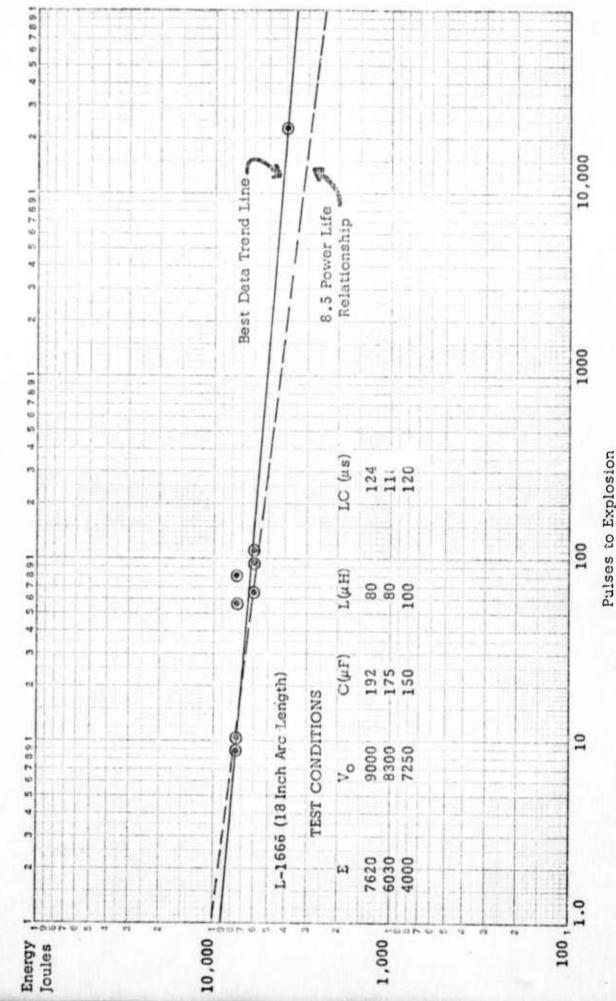
FIGURE 3. HIGH ENERGY LIFE TESTS

The most extensive lamp life data was collected on 6, 18 and 30 inch arc length lamps. Examination of Figures 3 and 4 suggests that the best fit lamp life vs. energy line appears to vary somewhat from previously established data (referenced in reference 1). The effect of this possible slope change appears to have the effect of slightly depressing the single shot explosion energy for long lamps, but substantially increasing expected lamp life when these lamps are operated at less than 50 or 60% of explosion energy. It also suggests that for 18 and 30 inch lamps, million pulse life expectancy might be achieved at 0.3 of explosion energy rather than at 0.2 of explosion energy as was previously thought. Many more lamp tests would be required to ascertain whether or not these apparent changes are really significant.

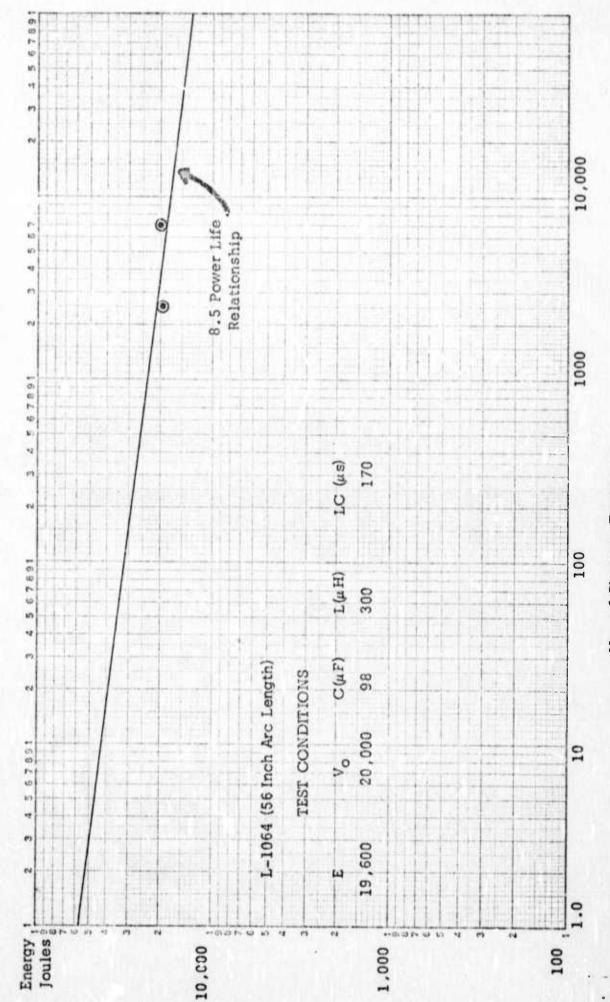
No. of Shots to Explosion FIGURE 5. HIGH ENERGY LIFE TESTS

Out of a total of 24 tests performed at more than 0.4 of explosion energy, only one abnormal early failure was noted. One of the 56 inch arc length lamps suffered a cracked seal but the lamp envelope was not destroyed. In spite of this early failure, the data point (shown on Figure 5) still results in reasonably good grouping of the data.

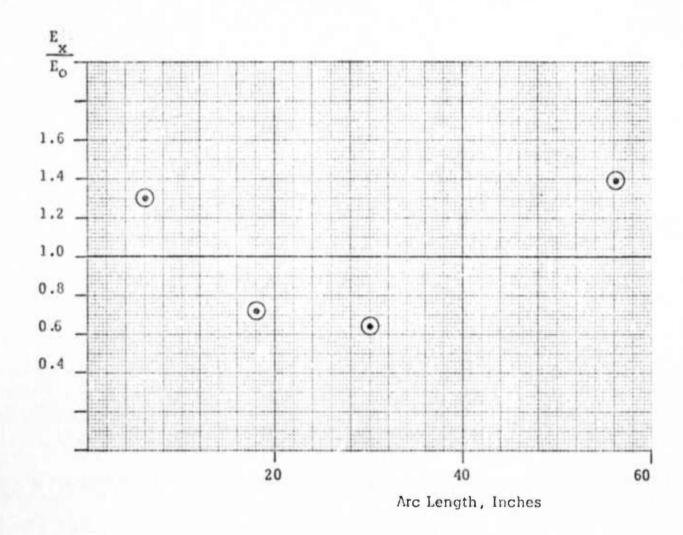
FIGURE 6

EXPLOSION LIMIT (Ex) AS A FUNCTION OF ARC LENGTH

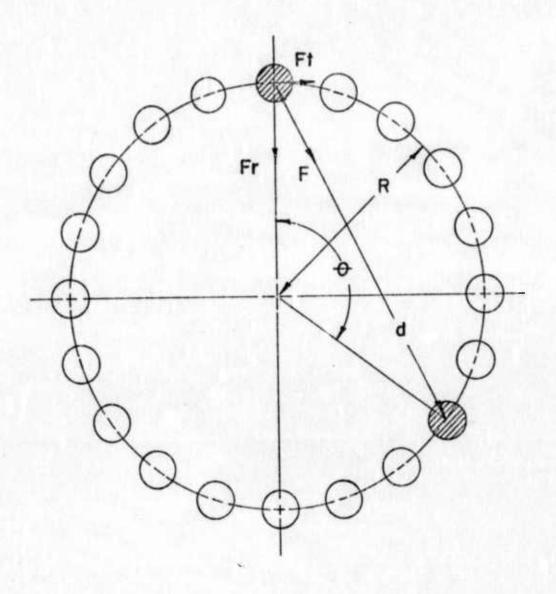
FIGURE 7. Magnetic Forces on Conductors in Cylindrical Configuration

The force between any two cylindrical conductors with their axes lying on the surface of a larger cylinder of radius R, as shown in Figure 7 and carrying equal currents, is then

directed outward, since the number of outward contributions is one greater than the number of inward contributions. In either case, the tangential component of the force on the given conductor vanishes because of symmetry, as can be seen from consideration of Figure 7.

As an example, we calculate the magnetic forces for the case of 20 lamps, each carrying a current of 3500 A, with their axes on a reference cylinder of 5.5 cm radius. If all of the currents are in the same direction, the radial component of force on each lamp is 29.1 pounds force per foot of length. If the currents are in opposite directions in alternate lamps, the force per foot of length is only 1.53 pounds. If one lamp fails to fire, a tangential component of 9.66 pounds force per foot of length is exerted on the lamps on either side of it, and smaller tangential forces are exerted on its more remote neighbors.

If, in the arrangement of 20 lamps with currents in opposite directions in adjacent lamps, one adjacent pair fails to fire, the radial force on the remaining lamps remains unchanged and the tangential force on a lamp next to the pair not firing becomes 4.96 pounds force per foot of length. The resultant force on this lamp is then 5.18 pounds per foot.

If the distance between supports is three feet, the maximum tensile stress in the quartz due to the magnetic forces is 165 psi if all lamps fire. If one adjacent pair fails to fire, the maximum stress in the lamps on either side of this pair is 536 psi. If the external connections were such that a single lamp could fail to fire, the maximum stress in its closest neighbors would be 1042 psi. Finally, if the lamps were connected so that current flowed in the same direction in all of them, the maximum tensile stress in each lamp, due to the radial magnetic force, would be 3140 psi.

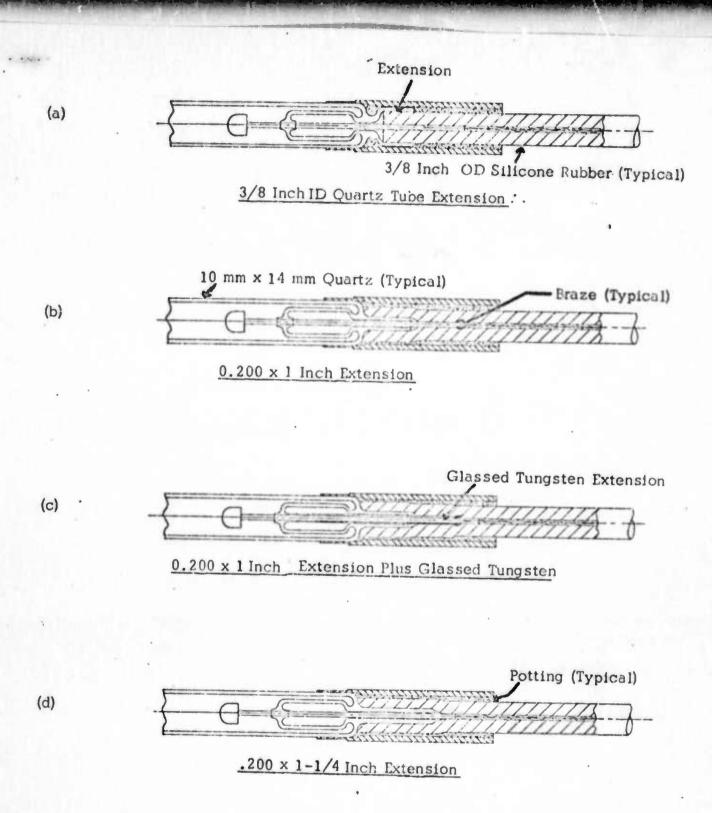
The various designs investigated are illustrated in Figure 8. Design A was discarded because of difficulty in manufacturing. Designs B and C were discarded because high voltage tests of sample structures showed that these designs would not provide adequate voltage isolation between the current carrying conductor and the metal support sleeve.

Design D was adopted for the tests under this contract. A sample lamp end was constructed as shown in Figure 8D, and was hi-potted to 50 kV dc for two minutes without breakdown. The same sample was then subjected to a pulse test in which the center conductor was pulsed to 40 kV with a pulse duration of approximately 2 μs at a pulse repetition rate of 10PPS for approximately 50 hours. After this test there was no visible or electrical sign of degradation of the insulation system.

During construction of the test lamps used on this program it was found that while the Design 8D is adequate from the standpoint of high voltage breakdown, it is mechanically weak and results in a high attrition of lamps during installation of the insulating system. Design 8E, incorporating a thicker quartz extension, is recommended for future lamp construction.
